**Flood Control Project Maintenance  
Levee Inspections**

**Fall 2018 Levee Maintenance Deficiency Summary Report**

**Sacramento River Basin**

**Butte County Department of Public Works**

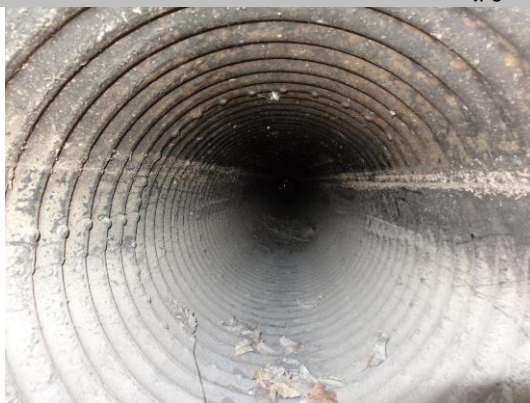
Photo 3 of 3 : UCIP\_FA\_2018\_29705\_54922.jpg

LS view: inside view of CMP on levee slope. Looks clean and clear.

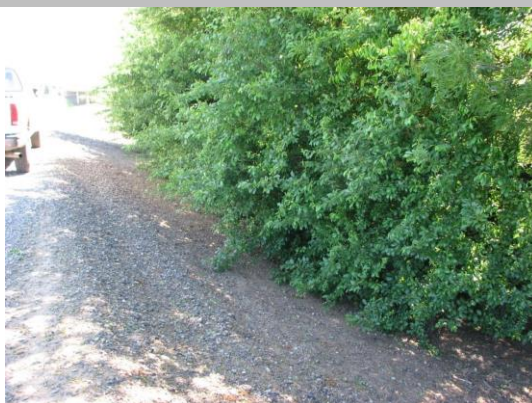
Photo 1 of 1 : FA\_2018\_NA0003\_64\_42\_20180905\_00022.jpg

View of the overgrown trees at the landside levee toe.

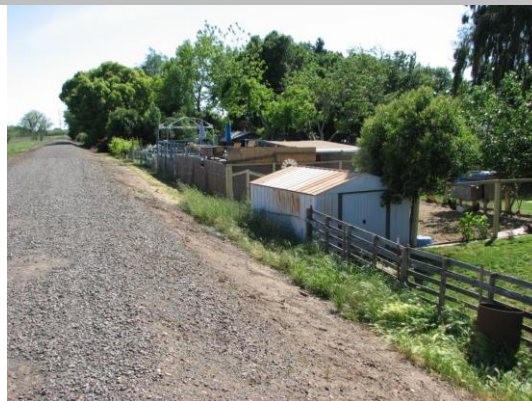
Photo 1 of 1 : FA\_2018\_NA0003\_64\_24\_20180905\_00006.jpg

View of a metal shed and fence along the landside toe.

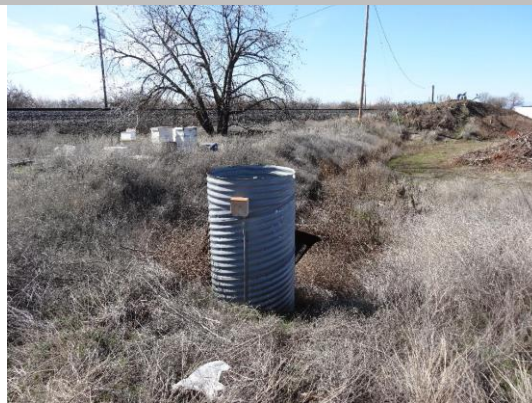
Photo 2 of 3 : UCIP\_FA\_2018\_30291\_55699.jpg

LS view: CMP riser on levee toe and drainage ditch perpendicular to the levee.

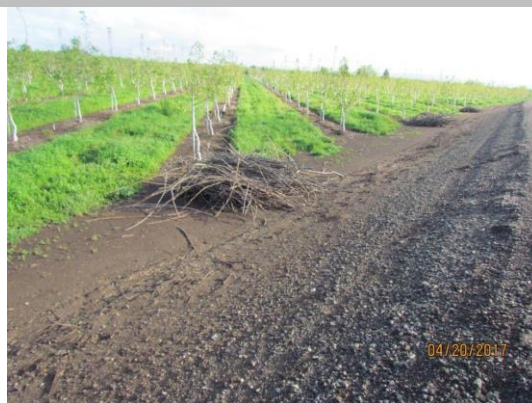
Photo 1 of 1 : FA\_2018\_NA0003\_64\_56\_20180905\_00032.jpg

View of the prunings along the landside toe.

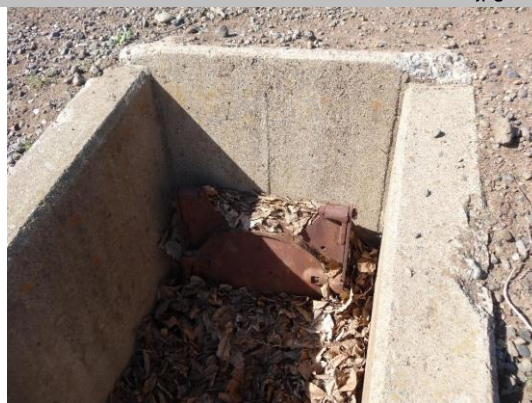
Photo 1 of 3 : UCIP\_FA\_2018\_30310\_55741.jpg

WS view: U type concrete headwall, pipe, and flapgate on levee slope.  
Vegetation debris blocking outlet.

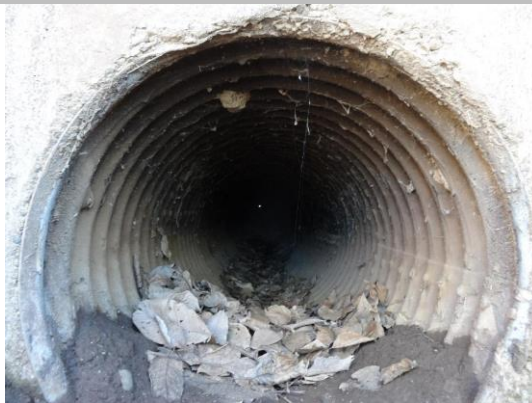
Photo 3 of 3 : UCIP\_FA\_2018\_30310\_55739.jpg

LS view: inside view of CMP on levee slope. Needs cleaning and clearing.

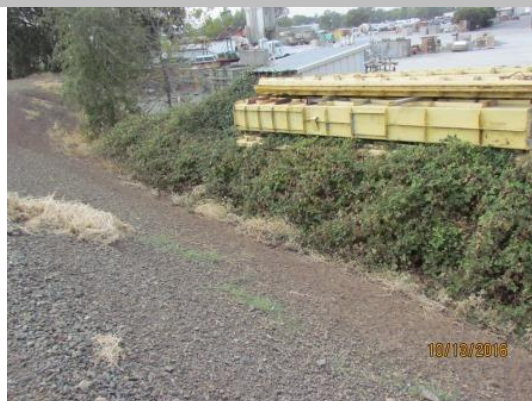
Photo 1 of 1 : FA\_2018\_NA0003\_64\_55\_20180905\_00031.jpg

View of the blackberries blocking visibility and access.

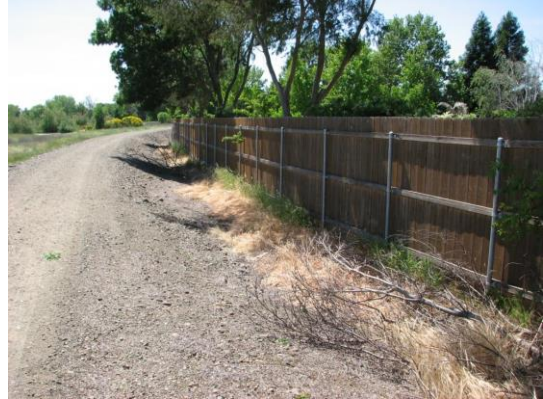
Photo 1 of 1 : FA\_2018\_NA0003\_64\_28\_20180905\_00009.jpg

View of the fence blocking visibility and access along the landside toe.

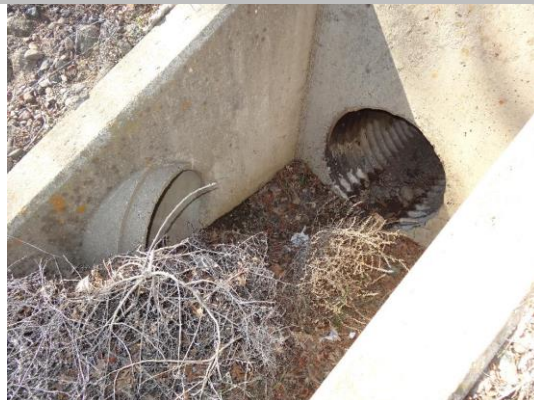
Photo 2 of 2 : UCIP\_FA\_2018\_30743\_56640.jpg

LS view: U type concrete headwall and CMP on levee slope. Vegetation debris and soil in inlet area.

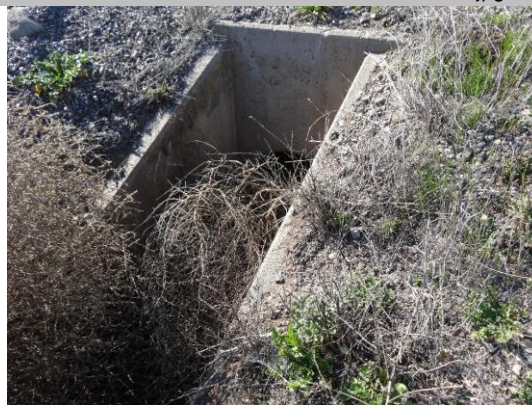
Photo 2 of 3 : UCIP\_FA\_2018\_30803\_56684.jpg

LS view: U type concrete headwall and CMP on levee slope. Vegetation debris and soil blocking inlet.

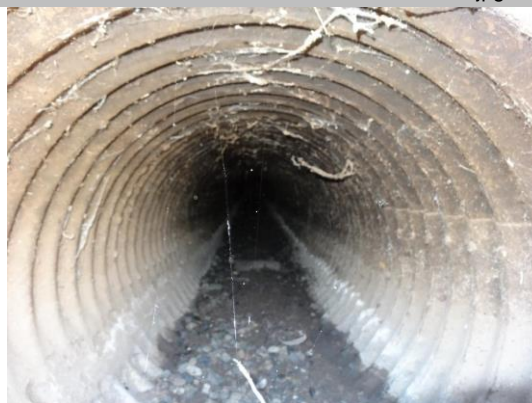
Photo 3 of 3 : UCIP\_FA\_2018\_31028\_56911.jpg

LS view: inside view of CMP on levee slope. Needs cleaning and clearing.

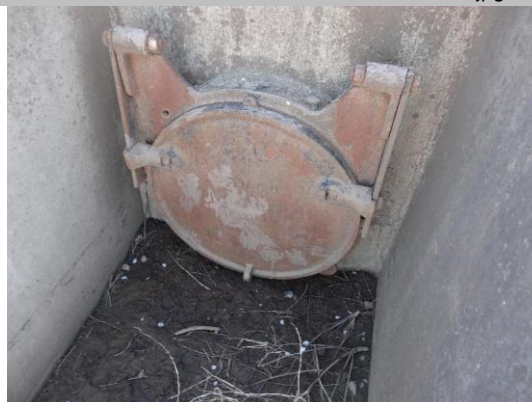
Photo 1 of 3 : UCIP\_FA\_2018\_31031\_56917.jpg

WS view: U type concrete headwall, pipe, and flapgate on levee slope. Soil/mud on outlet box.

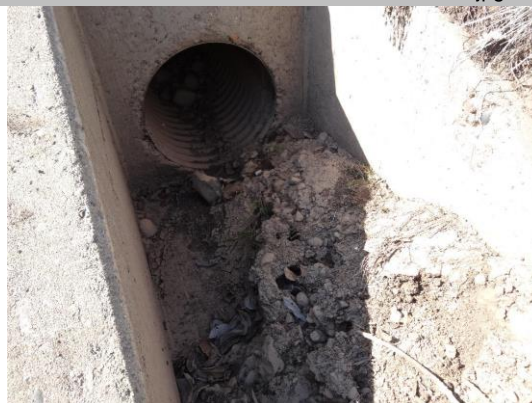
Photo 2 of 3 : UCIP\_FA\_2018\_31085\_56987.jpg

LS view: U type concrete headwall and CMP on levee slope. Soil/mud on inlet box.

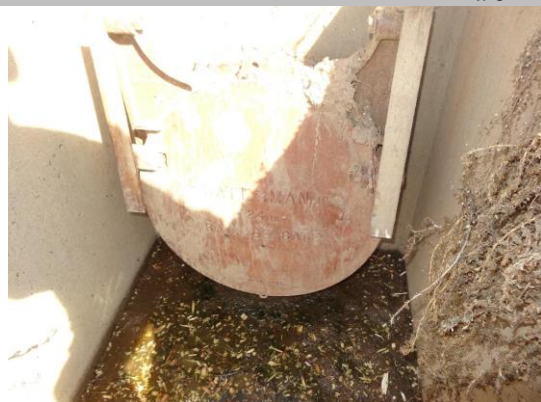
Photo 1 of 2 : UCIP\_FA\_2018\_31129\_57036.jpg

WS view: U type concrete headwall, pipe, and flapgate on levee slope. Soil/mud on outlet box.

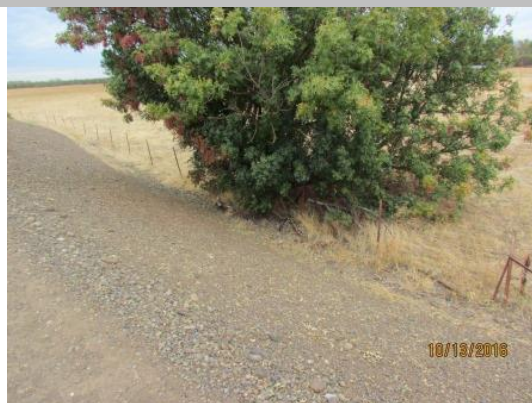
Photo 1 of 1 : FA\_2018\_NA0003\_67\_15\_20180905\_00004.jpg

View of the overgrown tree along the landside slope.

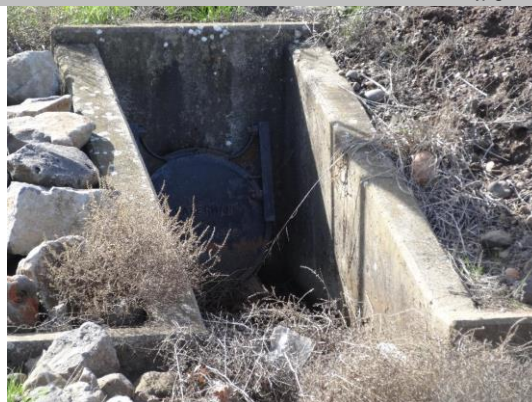
Photo 1 of 3 : UCIP\_FA\_2018\_32124\_58625.jpg

WS view: concrete headwall, pipe, and flapgate on levee slope. Vegetation and mud on outlet box.

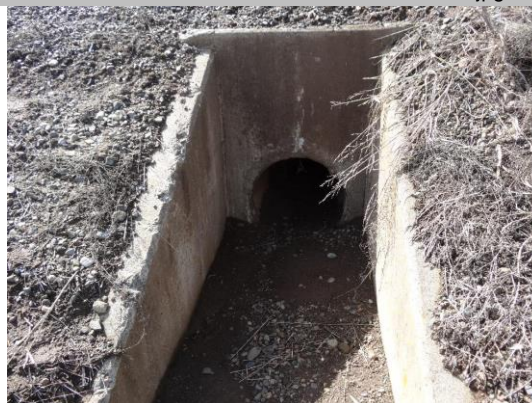
Photo 2 of 3 : UCIP\_FA\_2018\_31901\_58193.jpg

LS view: U type concrete headwall and CMP on levee slope. Soil/mud on inlet box.

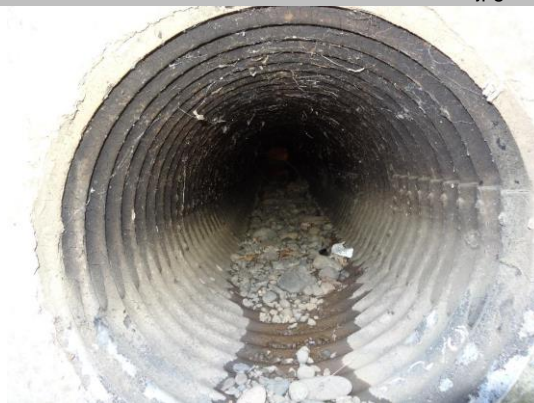
Photo 3 of 3 : UCIP\_FA\_2018\_32023\_58503.jpg

LS view: inside view of the CM pipe. Needs cleaning and clearing the pipe.

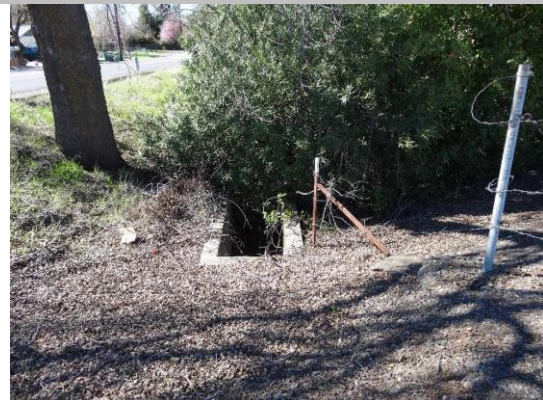
Photo 1 of 3 : UCIP\_FA\_2018\_32144\_58644.jpg

LS view: U type concrete headwall of CMP culvert on levee slope. Vegetation debris and mud on inlet box.

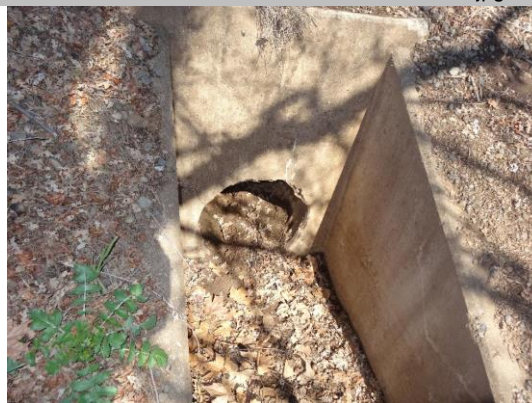
Photo 2 of 3 : UCIP\_FA\_2018\_31963\_58383.jpg

LS view: U type concrete headwall and CMP on levee slope. Vegetation debris and mud on inlet box.

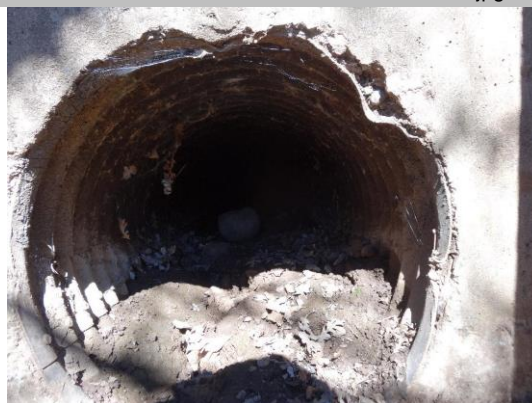
Photo 3 of 3 : UCIP\_FA\_2018\_31963\_58385.jpg

LS view: inside view of CMP on levee slope. Needs cleaning and clearing.

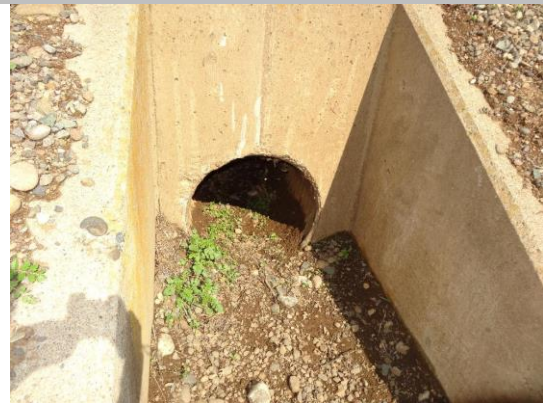
Photo 2 of 3 : UCIP\_FA\_2018\_31965\_58394.jpg

LS view: U type concrete headwall and CMP on levee slope. Vegetation debris and mud in inlet box.

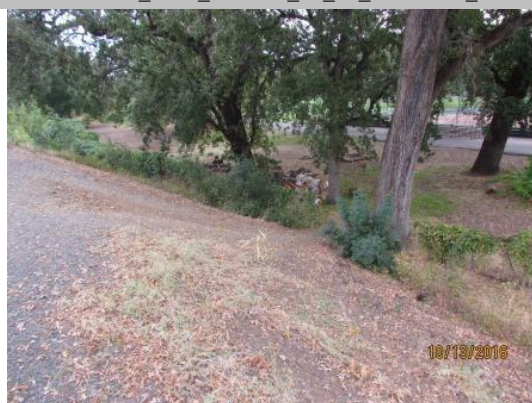
Photo 1 of 1 : FA\_2018\_NA0003\_69\_11\_20180905\_00001.jpg

View of the damaged slope by foot traffic.
